Circular regarding the use of high strength bolting assemblies for pre loading

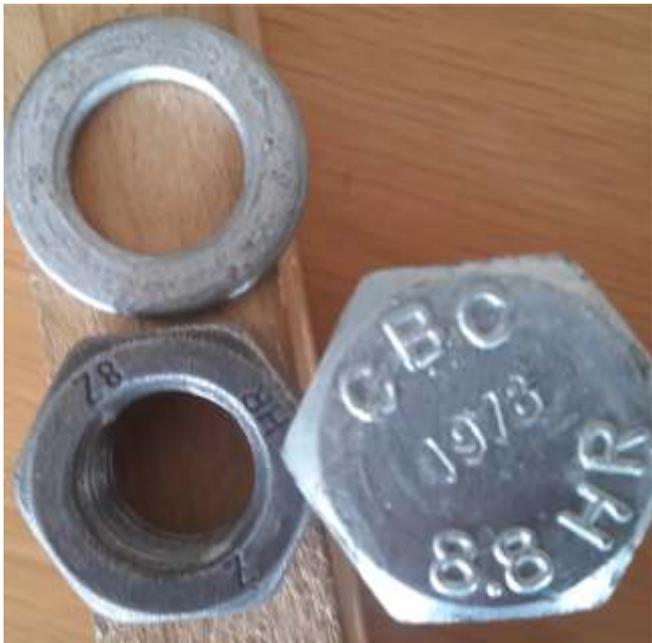
The nut is pre lubricated thus giving it an apparent different finish to the traditional HDG finish which is on the bolt and washer.
